Development, Testing, and Evaluation of Visual Landing Aids
Consolidated Progress Report for the Period January 1 to March 31, 1965

Development, Testing, and Evaluation of Visual Landing Aids

Consolidated Progress Report to
Ship Aeronautics Division
and
Meteorological Management Division
Bureau of Naval Weapons
Department of the Navy
and to
Federal Aviation Agency

For the Period
January 1 to March 31, 1965

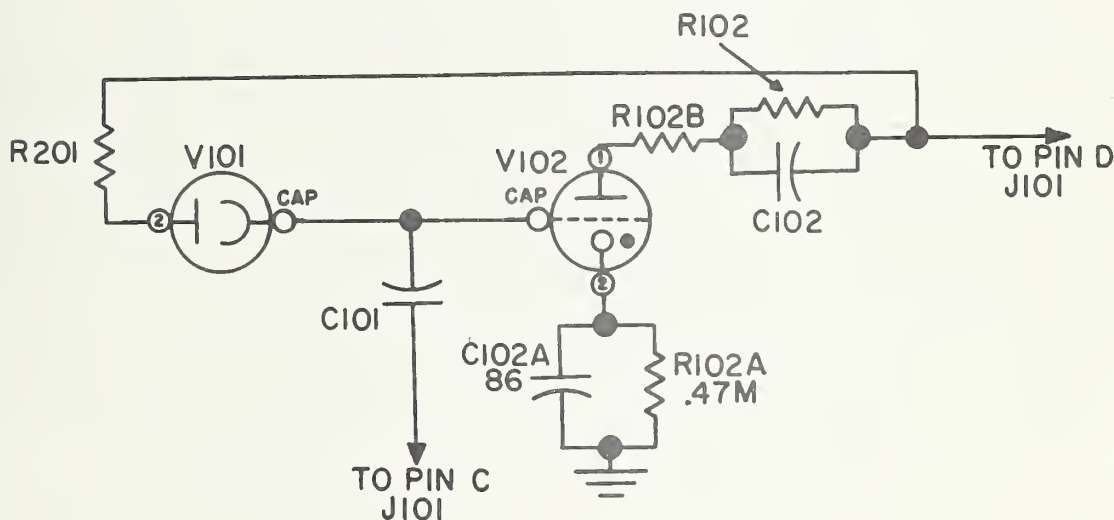
Figure 2. Modified Transmissometer Photopulse Unit

High Pulse Rate Receiver. Tests of a method of increasing the pulse rate of transmissometer photopulse units by modifying the circuit by the addition of R102A and C102A as indicated in figure 2 have been completed.

With the modified photopulse unit it was possible to obtain a pulse rate, in clear air, greater than 20,000 pulses per minute, at least 5 times the pulse rate of the conventional photopulse unit.

The sensitivity of the unit was satisfactorily stable. However, when the tube initially used for V102 was replaced with other type WL-759 tubes, wide variations in clear weather pulse rate, from 2 to 20 times the pulse rate of the unmodified unit, were observed. Some of the trigger tubes were unstable when operated in the modified unit. In addition, most of the trigger tubes showed wide deviations from linearity. Hence there appears to be no object in continuing further work on this circuit. Tests of the feasibility of using a photomultiplier in place of the photo-tube have been started.

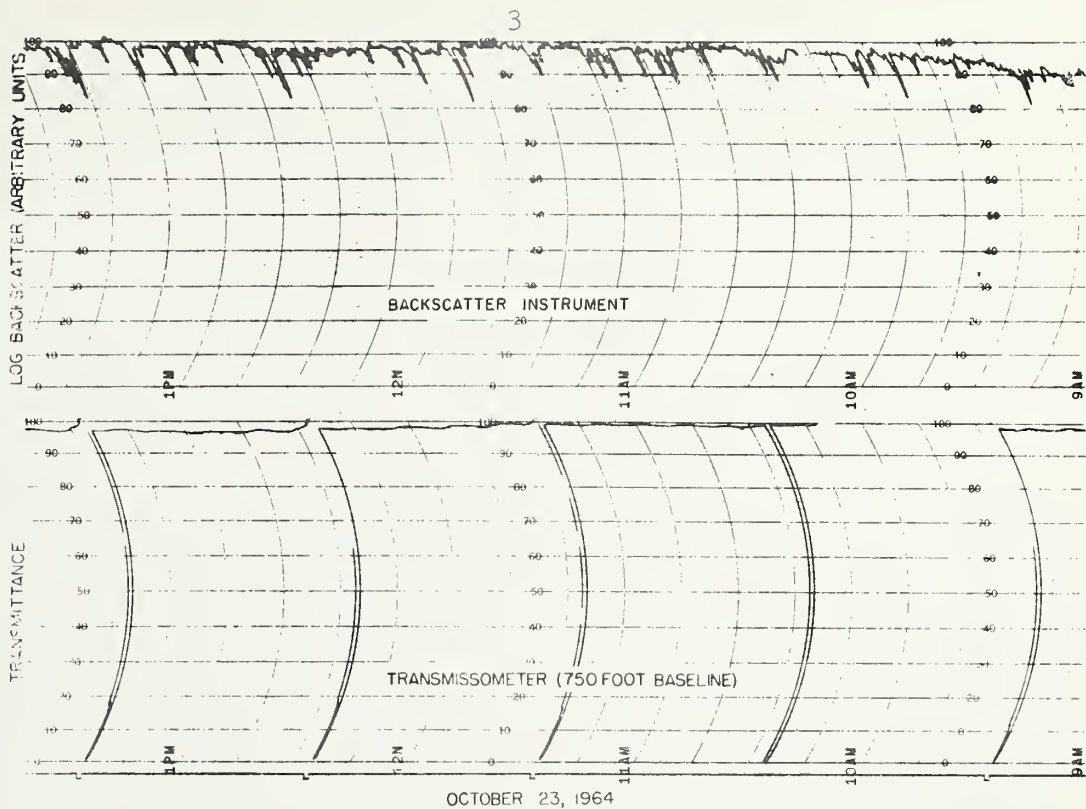
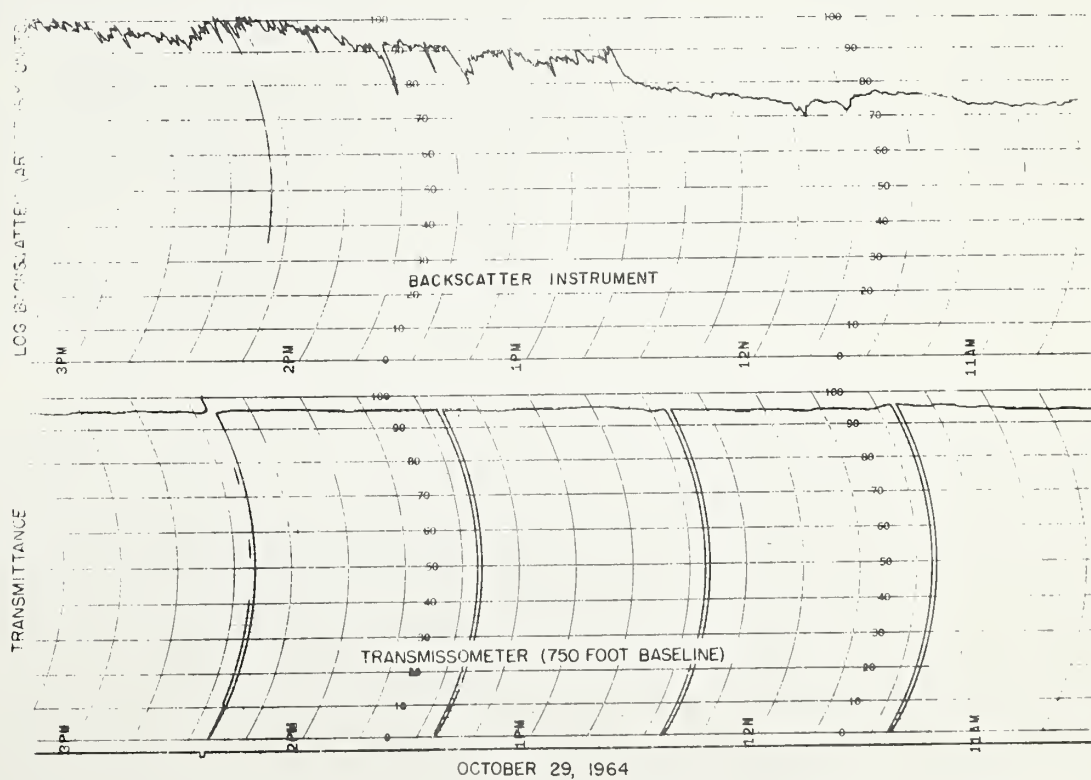
Figure 1. Simultaneous records of the backscatter visibility meter and the transmissometer at NBS Washington. The sharp dips in the backscatter meter readings are caused by local smoke and blowing leaves.
NBS Report 8920.

Data are being collected in a variety of weather conditions relating the measurements of the feasibility model of the shipboard visibility meter to measurements of transmittance made with a 750-foot baseline transmissometer. These measurements indicate that, as would be expected, even minor random variations in atmospheric transmittance which occur in only small volumes have a greater effect on the backscatter measurements than they do on direct measurements of transmittance. See figure 1.
